## Earthquake Countermeasures of the Shinkansen

## World's Tallest Freestanding Broadcast Tower Fuses Traditional and Leading-Edge Technologies to Ensure Safety

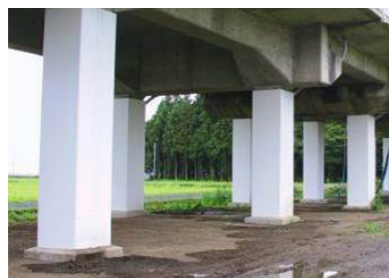
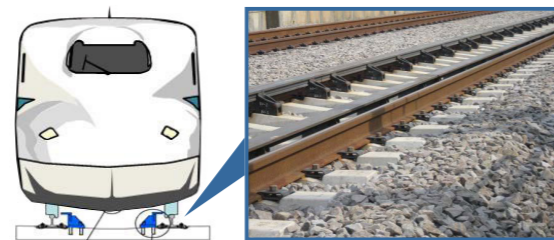
1. The Early Earthquake Detection System demonstrates its extraordinary effectiveness each time an earthquake hits, ensuring the safety of the high-speed rail service. Development is currently under way to improve the system's accuracy and response speed. 2. The pillars of elevated tracks have been seismically reinforced with steel plates. The white areas are the parts that have been reinforced. 3. Several measures are in place to prevent derailment. One such measure is the Derailment Prevention Guards installed inside the rails. Another measure is the installation of protrusions to prevent derailment placed on either side of the cars.

Since it began service, the Shinkansen has been equipped with an early earthquake detection system. When the first slight tremors from seismic waves are detected, electrical power is shut down, and the emergency brakes are applied, thereby reducing the speed of the train to a considerable degree before the strong tremors hit. The system is constantly upgraded, and it currently takes only about two seconds for the system to activate the device after primary seismic waves are detected.

Sophisticated earthquake countermeasures have been implemented in ground facilities as well. During the Great Hanshin-Awaji Earthquake in January 1995, elevated rails of the Shinkansen collapsed, causing massive damage. In light of this bitter experience, the railway companies retrofitted the elevated rail bridges against earthquakes, performing work such as reinforcing the bridge piers with steel plates. Since then, no bridge piers have been seriously damaged in major earthquakes.

During the magnitude 6.8 Chuetsu Earthquake in October 2004, a train in service derailed. Fortunately, the cars did not come off the tracks completely and did not overturn because the rail became caught between the wheels and the equipment under the cars, causing the train to stop. Having learned from this incident, the railway companies equipped cars and tracks with derailment prevention devices.
